## Amesbury Street: Dune Walkway Profile

Site Assessments: March 26, 2024, July 29, 2024, and May 23, 2025

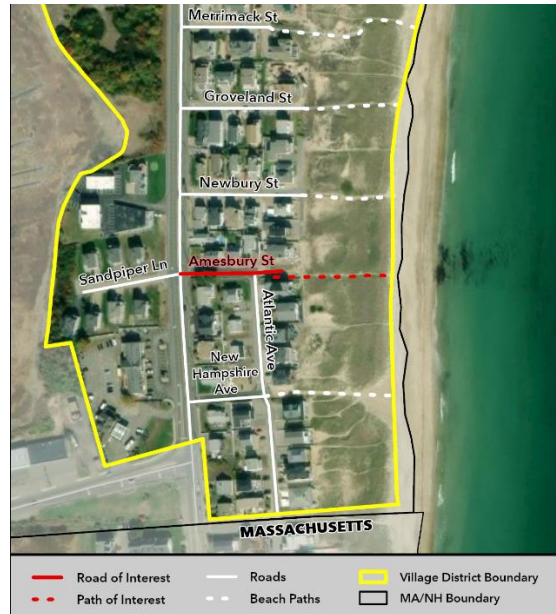
| Structure Conditions and Observations | |
| Road to Beach | 433 ft |
| Boardwalk Length | 363 ft |
| End of boardwalk to beach | 70 ft |
| Walkway Width | 4 ft |
| Boardwalk Material | <ul style="list-style-type: none"> <li>Asphalt apron</li> <li>pressure treated wood connected by galvanized cable</li> </ul> |
| Attached pathways | 1 |
| Benches | 4 |
| Additional Features | <ul style="list-style-type: none"> <li>Railings &amp; viewing platform</li> <li>Fire hydrant at entrance</li> </ul> |

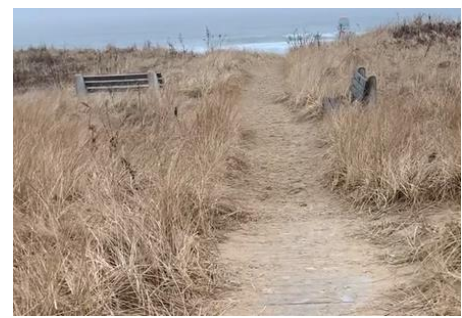
Seaward Side

- The beachgrass grassland is well-established and the seaward end of the walkway is well vegetated (Figure 5).
- Two benches are located about halfway between the dune crest and the beach entrance—one on the north side, oriented perpendicular to the walkway, and one on the south side, oriented parallel to it (Figure 6).
- The end of the boardwalk is partially covered by sand.

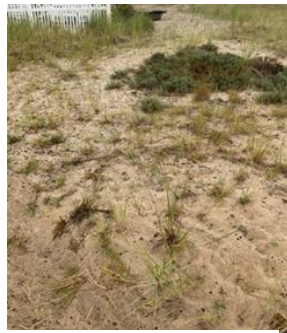
Figure 2. Wooly beach heather near homes

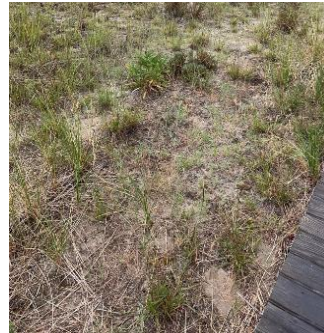
Figure 3. Vegetation non-characteristic of dune

- Remove invasive species. Consider replacing the vegetation along the landward side of the walkway, where habitat quality is low, with native dune species.

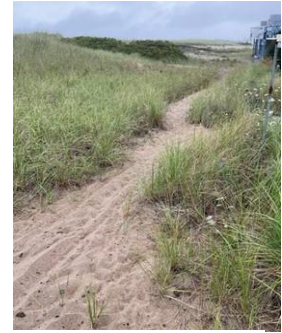
- The walkway is relatively straight and flat, with a gentle incline leading up to the dune crest.
- A small number of boards show signs of bowing or tilting.
- A railing is installed along the south side of the walkway on the incline section.
- Milk weed, a native species, was observed along the landward side of the walkway (Figure 1).
- A small patch of wooly beach heather, a rare species, is growing near the homes. The area around is sparsely vegetated (Figure 2).
- Areas of degraded habitat exist along landward side of the walkways, as evidenced by invasive species and species non-characteristic of dunes (Figure 3).
- A walking path runs perpendicular to the municipal walkway along the landward edge of the dunes (Figure 4).

Figure 4. Perpendicular paths connect to

- Install a Mobi Mat or similar ADA-compliant beach access mat at the end of the walkway to improve accessibility.
- The walking path running perpendicular to the municipal walkway along the landward edge of the dunes is a nice example of landowner access paths to the beach that limit impacts to the dune. Consider this approach at other walkways.
