Andover Street: Dune Walkway Profile

Site Assessments: March 5, 2024 and July 25, 2024

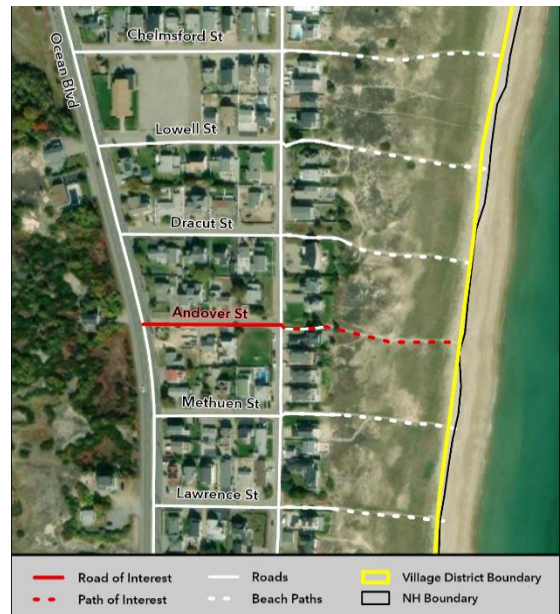
Structure Conditions and Observations	
Road to Beach	537 ft
Boardwalk Length	467 ft
End of boardwalk to beach	70 ft
Walkway Width	4.0 ft
Boardwalk Material	<ul style="list-style-type: none"> Asphalt apron Pressure treated wood connected by galvanized cable
Attached pathways*	3
Benches	5
Additional Features	Railing on southern side of walkway along the landward side of dune crest incline.
*Human-made pathways connected to the municipal walkway

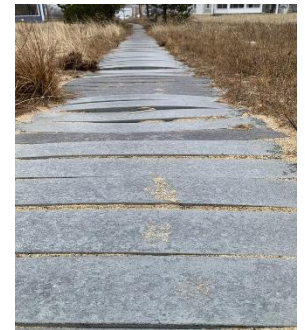
Figure 2. Uneven boards

- Pine trees near the restoration area may be Austrian pine (*Pinus nigra*) or Japanese black pine (*Pinus thunbergia*) (Figure 1).
- The section beyond the newly replaced part before the incline to dune crest has many bowed planks posing tripping hazards (Figure 2).

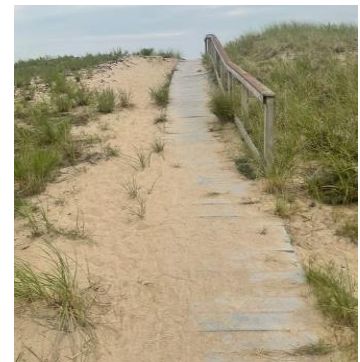
Figure 3. Unvegetated areas on northside of boardwalk

- An unvegetated area exists on the north side of the boardwalk where it is steep, slippery, and boards are missing (Figure 3).
- Areas of dense and intact *Hudsonia* maritime shrubland are intersected by walking paths through the dunes directly to homes resulting in areas of bare sand and sparse vegetation.

- Revegetate bare areas with native sand dune plants.
- In areas of suspected dune die-off, consider planting a diversity of sand dune species and/or treating the area with a lime and fertilizer.

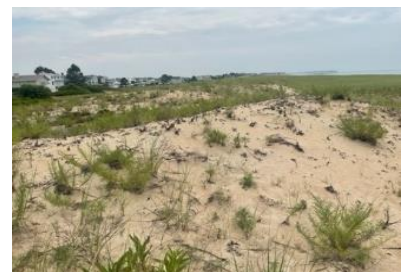
Figure 4. Suspected dune die-off

- At the dune crest there are two benches on the south side of the walkway. Each are positioned at an approximate 45-degree angle to walkway.
- Areas of suspected dune die-off exist along the dune crest and landward side of the dune (Figure 4).
