## Ashland Street: Dune Walkway Profile

Site Assessments: March 26, 2024 and August 27, 2024

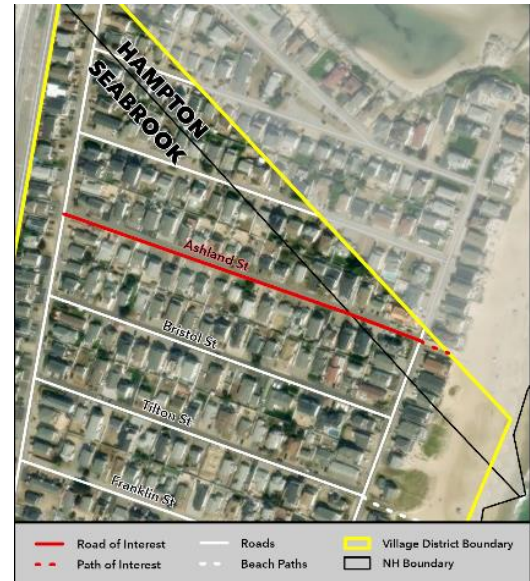
Walkway Conditions and Observations	
Road to Beach	152 ft
Boardwalk Length	82 ft
End of boardwalk to beach	70 ft
Walkway width	5.3 ft
Boardwalk Material	<ul style="list-style-type: none"> <li>Asphalt apron,</li> <li>Pressure treated plywood connected by cable</li> </ul>
Attached pathways*	None
Benches	4
Additional Features	<ul style="list-style-type: none"> <li>Emergency Access point</li> <li>Wide enough for vehicular access.</li> <li>Wooden posts and beachgrass separating walkway from adjacent vehicle access way.</li> <li>Seasonal Mobi Mat installed to extend wooden walkway over sand to beach</li> </ul>
*Human-made pathways connected to the municipal walkway

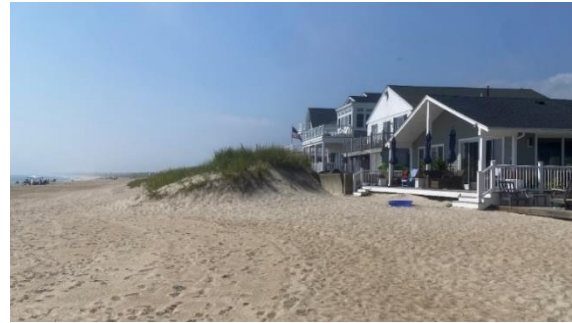
Figure 1: Small dune system in front of homes to the south.

- No dunes are present adjacent to the walkways although small remnant dunes are present in front of homes to the south (figure 1).
- The beach entrance supports vehicle access to the beach to the north side of the walkway.

- Periodically remove excess sand from the walkway surface to maintain accessibility.
- Explore opportunities to use the removed sand beneath the walkway to raise its elevation and improve resilience.
- Allow the small, fragmented dunes to continue developing. Limit disturbance.
- Restore sand dune to create a narrow path on the seaward end of the walkway.
- Consider orienting the seaward end of the walkway away from the dominant wind and wave directions.

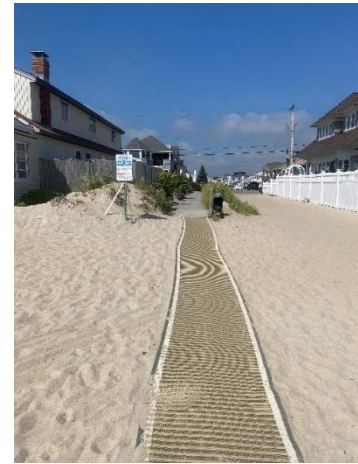
Figure 2: Mobi mat observed in August

- Planters with Canna lilies are present along the south side of the walkway.
- Mobi mat observed in August (Figure 2).
