Dracut Street: Dune Walkway Profile

Site Assessments: March 5, 2024 and July 9, 2024

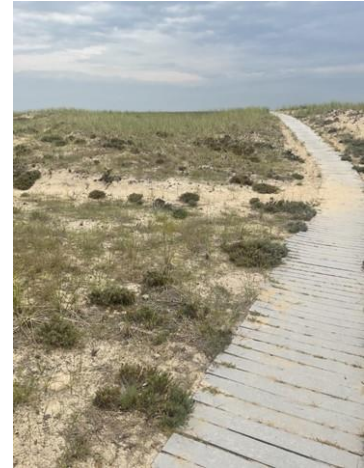
Figure 1: Bare sand strip perpendicular to walkway

- The initial portion of the walkway is flat and stable.
- There are two benches at the beginning of the walkway positioned parallel to it.
- Areas of bare sand exist within the dune, including adjacent to the walkway, that appear to be a result of pedestrian traffic (Figure 1).
- Scotch pine (*Pinus sylvestris*, NH invasive species watch list) and possibly Japanese black pine (*Pinus thunbergii*; nonnative) or jack pine are present on site (Figures 2 & 3).
- The landward end of the walkway is colonized by predominantly nonnative species including species considered invasive or potentially invasive in NH (Figure 4).
- This area has well-established, contiguous and dense beachgrass grassland.

- Remove excess sand from the lower portion of the boardwalk to restore accessibility and reduce the risk of structural strain.
- Conduct regular maintenance to prevent future sand buildup, especially after storms.
- Install a Mobi Mat or similar ADA-compliant beach access mat at the end of the walkway to improve accessibility.
- Limit pedestrian traffic through the dune and revegetate the bare areas of dune near the walkway.
- Remove invasive species and revegetate the areas adjacent to the walkway near the road with native dune species.

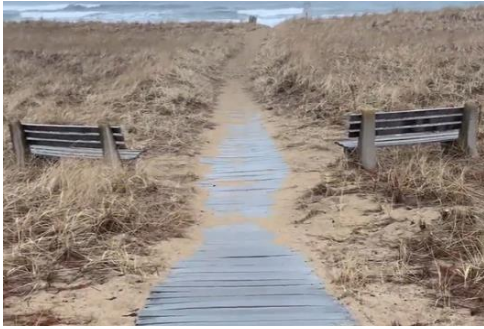
Figure 5: Bottom of walkway buried

- The lower portion of the walkway is buried in sand near the beach access point (Figure 5).
- There are two benches, one on the north and south sides of the walkway. Each are positioned at an approximate 45-degree angle to walkway.
- The seaward end of the walkway is narrow and there is evidence of new beachgrass growth (Figure 6).
