Groveland Street: Dune Walkway Profile

Site Assessments: March 5, 2024 and July 29, 2024

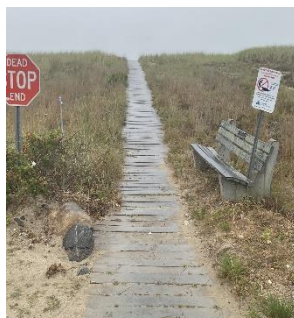
Walkway Entrance &
Landward side

- The vegetation along the walkway appears to be cut (Figure 1).
- A bench on the south side near the entrance is oriented parallel to the walkway
- Noticed individual walkways from homes through the dunes, running parallel to the municipal walkway.
- Several sections of the walkway have bowed or loose planks.
- Poison ivy was observed along the north side of the dune walkway (Figure 2).
- The walkway becomes noticeably steep as it approaches the crest of the dune.

- Conduct regular maintenance to prevent future sand buildup, especially after storms.
- Inspect and replace any missing or damaged planks to improve safety and stability.

- Remove the invasive species near the landward end of the walkway and revegetate the area with native dune species.
- Consider replacing the vegetation along the landward side of the walkway, where habitat quality is low, with native dune species.

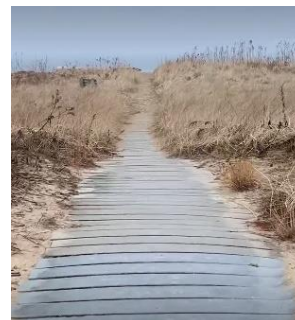
Seaward Side

- The beachgrass grassland on the seaward end of the walkway is well-established (Figure 3).
- One bench located on the northside of walkway oriented at a 45-degree angle and set back into the dune.
- The lower portion of the boardwalk near the beach is partially buried by sand.
- Unvegetated areas were observed along the seaward side of the walkway near the homes. Adjacent to the walkway areas of disturbed habitat were observed (Figure 4). Sparse patches of wooly beach heather (a rare species) were also observed in this area.
- A bench is located at an approximately 45-degree angle to the walkway, facing the ocean (Figure 5). The impacts to dune vegetation are confined to the small area in front of the bench. This bench serves as an example of how to position a bench to maximize the view for bench users while limiting impacts to the dune.
