Hudson Street: Dune Walkway Profile

Site Assessments: February 14, 2024 and July 25, 2024

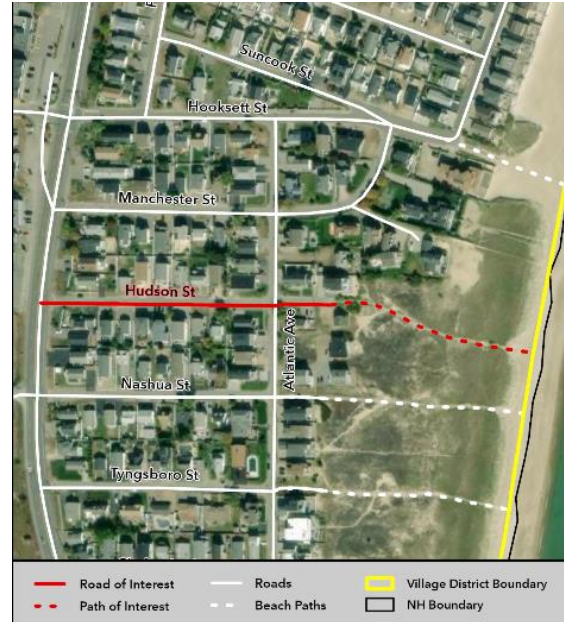
Structure Conditions and Observations	
Road to Beach	480 ft
Boardwalk Length	420 ft
End of boardwalk to beach	60 ft
Walkway Width	4.0 ft
Boardwalk Material	Asphalt apron; pressure treated wood connected by cable
Attached pathways*	3
Benches	3
Additional Features	<ul style="list-style-type: none"> • Birdhouses • Stone patio blocks alongside of path with handicap symbol
*human-made pathways connected to the municipal walkway

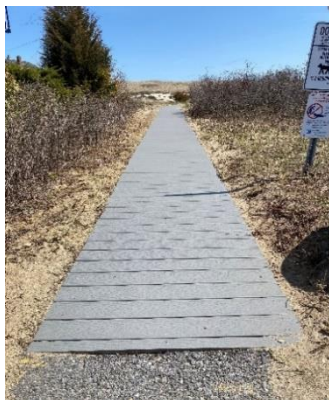
Walkway entrance (2025)

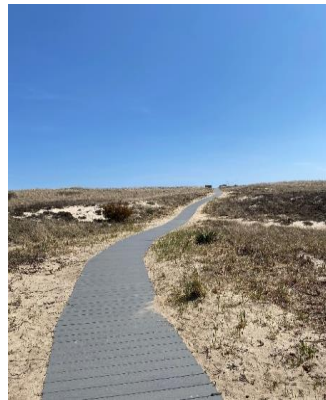
Landward side (2025)

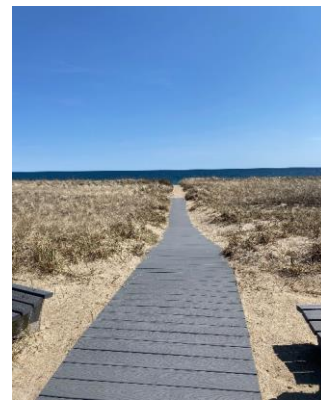
Seaward side (2025)

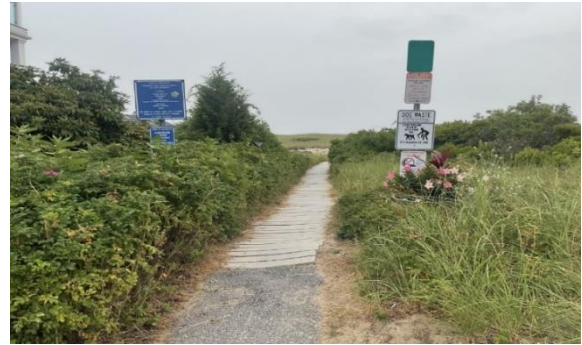
- The boardwalk was replaced in December 2024.
- Invasive species at the entrance to the Hudson St walkway, including beach rose on the left side of the image, and Asiatic bittersweet climbing the tree in the background (Figure 1).

Figure 1: Invasive species at the entrance to the walkway

- Install a Mobi Mat or similar ADA-compliant beach access mat at the end of the walkway to improve accessibility.
- Delineate paths from homes to walkway to minimize dune impact.
- Revegetate the bare areas of dune near homes with native sand dune plants.
- Consider removal of invasive species and revegetation with native species.
- Benches placed at an angle (~45°) generally appear to have less impact on the surrounding dune than benches placed perpendicular to the walkway. Consider positioning benches at a 45° angle to the walkway when practicable and revegetating the areas around them, other than directly in front.
- In areas of suspected dune die-off, consider planting a diversity of sand dune species and/or treating the area with a lime and fertilizer (see die-off area planting suggestions).

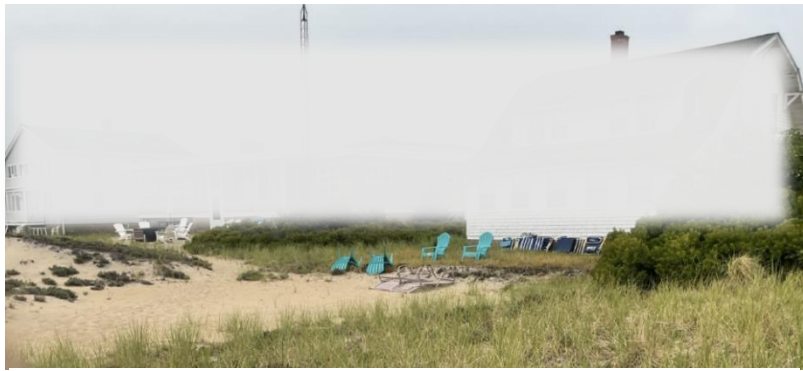
- Areas of dune die-off are vegetated with seaside goldenrod.
- Areas of bare sand adjacent to walkway near homes to the south (Figure 2).
- Piles of sand adjacent to the walkway suggest that sand is being shoveled from the walkway onto the dune.

Figure 2: Areas of bare sand adjacent to walkway near homes to the south

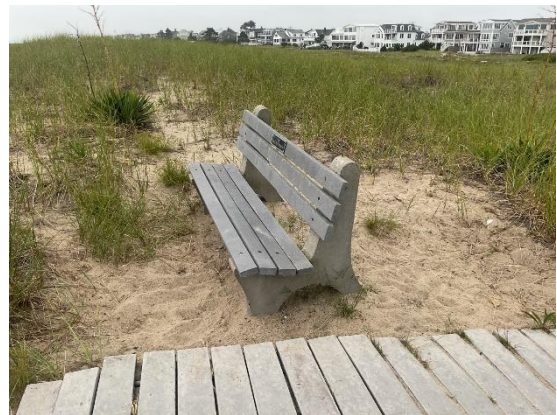
- At the dune crest there are two benches on both sides of the walkway.
- The areas surrounding the benches vary in condition. Some have minimal impact to the dune, and lack of vegetation only in front of the bench while others have more unvegetated areas surrounding them (Figure 3).

Figure 3: Bench placed perpendicular to the boardwalk exhibits surrounding unvegetated areas. Consider repositioning the bench and revegetating.
