Lowell Street: Dune Walkway Profile

Sie Assessments: March 5, 2024 and July 25, 2024

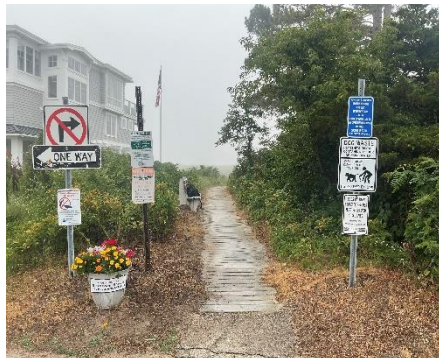
Walkway Entrance

- The initial portion of the walkway appears flat and stable.
- High density and diversity of invasive plant species found at the entrance to the walkway.
- *Hudsonia maritime* shrubland is dense and intact, particularly to the north of the walkway.
- Both Scotch pine (*Pinus sylvestris*, NH invasive species watch list) and Austrian/black pine (*Pinus nigra*; nonnative) are suspected on site (Figure 1).
- There is one bench along the north side of the walkway, positioned parallel to it.
- As the slope increases to the dune crest some boards are bowing which could cause a tripping hazard.
- Walking paths to homes have created unvegetated areas in the *Hudsonia maritime* shrubland to the south (Figure 2).

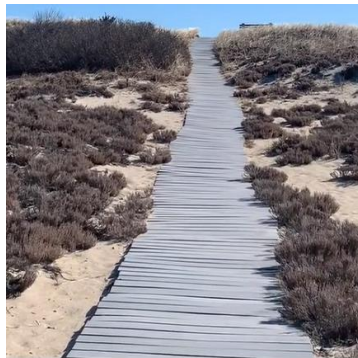
Landward Side of Dune

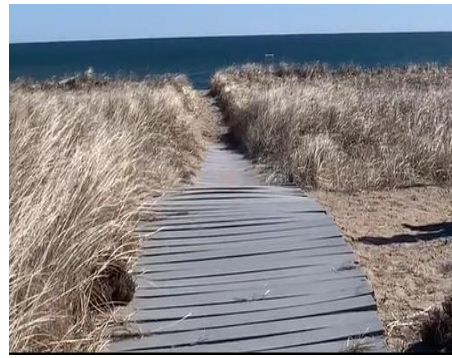
Seaward Side

- There is a bench positioned further into the dune and away from the walkway.
- The lower portion of the walkway is buried in sand near the beach access point.
- The seaward end of walkway is narrow and there is evidence of new beachgrass growth.
- Earthstar mushrooms found at this site (likely *Astraeus hygrometricus*).

- Consider routing walking paths from homes perpendicular to the walkway along the edge of the dune close to the houses to limit dune impacts.
- Seek positive confirmation of pine tree species and remove if confirmed to be non-native.
- Remove excess sand from the lower portion of the walkway to restore accessibility and reduce the risk of structural strain.

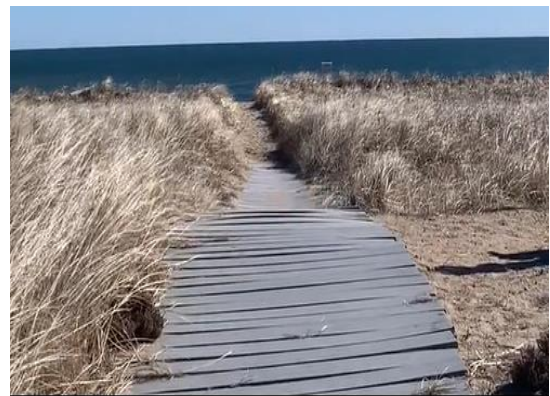
Figure 3: Some shifting of the boardwalk observed at the crest of the dune.

- There is one bench along the south side of the walkway that is positioned perpendicular to it.
- There is some evidence of the boardwalk shifting slightly at the dune crest (Figure 3).

- Inspect and replace any damaged or loose planks to improve safety and durability.
- Install a Mobi Mat or similar ADA-compliant beach access mat at the end of the walkway to improve accessibility.
- Given the high condition of the dune and density of invasive species, remove invasive species and revegetate the areas adjacent to the walkway near the road with native dune species.

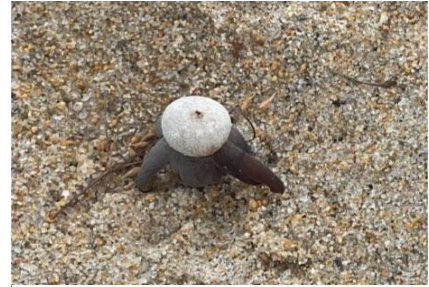
Figure 3: Earthstar mushroom found at this site

The mushroom observed at this site is likely in the genus *Astraeus* – the false earthstars (Figure 3). They are often called the “**Barometer Earthster**” as the rays of the star open and close based on the humidity.
