Merrimack Street: Dune Walkway Profile

Site Assessments: March 5, 2024, July 29, 2024, and May 23, 2025

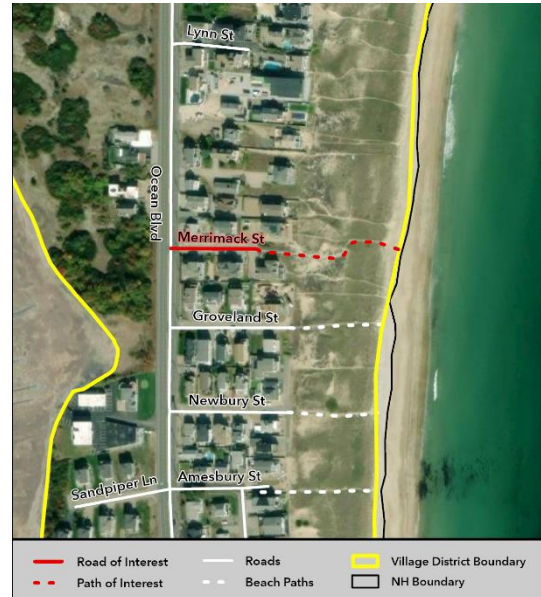
Structure Conditions and Observations	
Road to Beach	474 ft
Boardwalk Length	380 ft
End of boardwalk to beach	94 ft
Walkway Width	4.0 ft
Boardwalk Material	<ul style="list-style-type: none"> Asphalt apron Pressure treated wood connected by galvanized cable
Attached pathways	3 with others seen adjacent
Benches	1
Additional Features	<ul style="list-style-type: none"> Fire hydrant at entrance Seasonal Mobi Mat installed to extend wooden walkway over sand to beach
*Human-made pathways connected to the municipal walkway

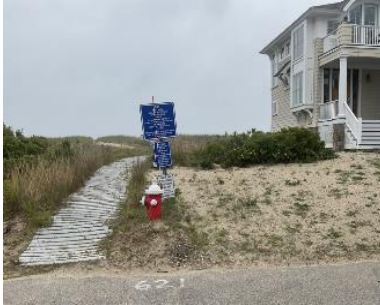
Figure 1. Unvegetated area near

- At the entrance the southern side of the walkway is unvegetated (Figure 1).
- Nonnative and/or invasive species are present at the entrance to the walkway near the road.
- The woolly beach heather is sparse throughout the back side of the dune with a large unvegetated area observed to the south of the walkway (Figure 2).
- Private walking paths from homes through the dunes and use of the dunes have contributed to many large unvegetated areas (Figure 3).

- Revegetate areas of bare sand and sparse vegetation with native sand dune species with a focus on the large, disturbed areas.

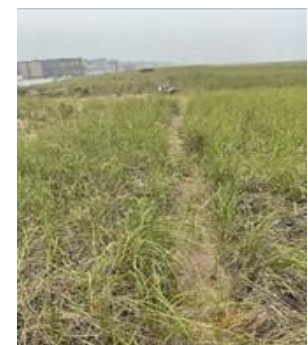
Figure 6. Path to bench set far into dune

- The beachgrass grassland is well established, though two invasive honeysuckle shrubs were observed on the seaward side of the dunes.
- Long path to bench set far into dune (Figure 6)
- Walking paths and use of the dunes have created many large unvegetated areas.
- The seasonal Mobi Mat extends the walkway closer to the beach but it does not make it all the way to the beach.
- Many small beach rose plants are growing to the south of walkway,
- The lower portion of the boardwalk is buried in sand near the beach access point.

- The locations of the bench on the dune crest and the bench in the dune to the north are resulting in impacts to dune vegetation, including rare species. Benches placed at an angle (~45°) generally appear to have less impact on the surrounding dune than benches placed perpendicular to the walkway. Consider positioning benches at a 45° angle to the walkway when practicable and revegetating the areas around them, other than directly in front.
