## Methuen Street: Dune Walkway Profile

Site Assessments: March 5, 2024, July 9, 2024, and May 23, 2025

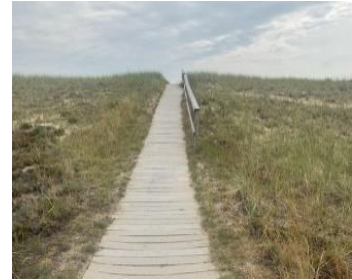
Figure 1. Landward side leading to dune crest

- The pine tree near the entrance appears to be a Japanese black pine (*Pinus thunbergii*).
- The walkway is relatively straight and flat, with a moderate incline over the dune crest.
- The vegetation along the walkway is close to the boardwalk suggesting pedestrians are staying on the walkway (Figure 1).
- The vegetated adjacent to the walkway appears to be mowed (Figure 1).
- Areas of dense and intact *Hudsonia* maritime shrubland and beachgrass grassland are fragmented by a wooden walking path through the dunes directly to homes contributing to areas of bare sand and sparse vegetation (Figure 2).
- A pile of grass clippings and rocks was observed in the dune.

- Increase native plant diversity by removing the pine tree, bittersweet, and the lawn grasses near the landward entrance and revegetate with native dune species.

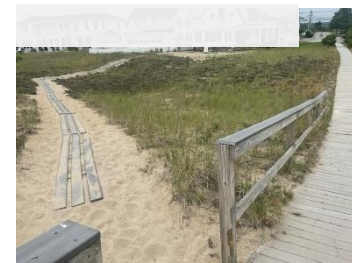
Figure 2. Areas of intact *Hudsonia* between walkway and private path

- Toward the dune crest, it appears some planks are coming loose (Figure 2).

- Inspect and replace any missing or damaged planks to improve safety and stability.
- Remove excess sand from the lower portion of the walkway to restore accessibility and reduce the risk of structural strain.

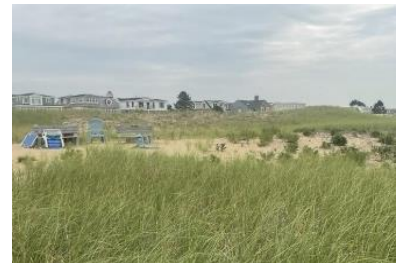
Figure 3. Dune die-off near benches

- A well-established beachgrass grassland exists at the seaward end to the south of the walkway.
- Large unvegetated areas were present to the north of the walkway.
- Two benches are located further into the dune requiring people to walk through the dunes to access them. Beach accessories may be stored here as evidence by the Adirondack chairs and beach chairs.
- An area of suspected dune die-off exists to the north of the walkway behind the bench area (Figure 3).
- A section of wooden planks at the end of the walkway is detached and made of a different material than the rest of the boardwalk (Figure 4).
- The lower portion of the walkway is buried in sand near the beach access point.
- Seaward end of walkway is narrow and the surrounding area is well vegetated.

- Move benches closer to the primary walkway. Remove beach chairs and Adirondack chairs and revegetate the area with native dune species. Benches placed at an angle (~45°) generally appear to have less impact on the surrounding dune than benches placed perpendicular to the walkway. Consider positioning benches at a 45° angle to the walkway when practicable

- Remove invasive species and revegetate with native dune species
- In areas of suspected dune die-off, consider planting a diversity of sand dune species and/or treating the area with a lime and fertilizer (see die-off area planting suggestions).
