Nashua Street: Dune Walkway Profile

Site Assessments: February 14, 2024 and July 25, 2024

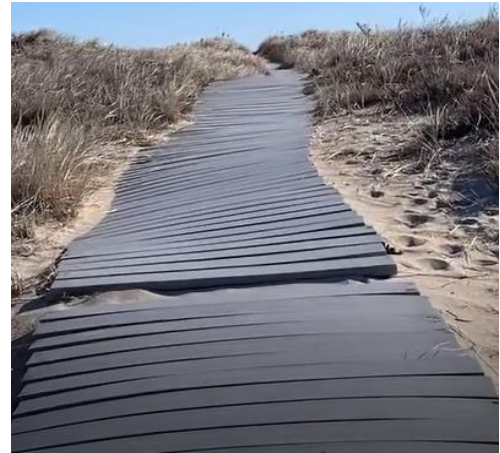
Figure 1: Missing boards; noticeable tilting.

- The initial portion of the walkway is flat and appears structurally stable.
- Nonnative and/or invasive species are present at the entrance to the walkway near the road.
- As the path begins to slope upward toward the dune crest, several boards show signs of bowing, and a few are missing (Figure 1).
- Near the dune crest, the walkway curves and exhibits noticeable tilting.
- Areas of bare sand and sparse vegetation were observed along the walkway.
- Bare sand areas appear to correspond with sections of walkway that has missing and unstable boards.
- Walking paths to homes have created large unvegetated areas (Figure 2).
- Vegetation adjacent to the path on either side appears to have been mowed (Figure 3).

- Inspect and repair loose or uneven planks to maintain a safe, level surface.
- Add non-slip surfacing on curved and inclined sections to improve traction and reduce the risk of slipping.
