Tyngsboro Street: Dune Walkway Profile

Site Assessments: February 14, 2024 and July 25, 2024

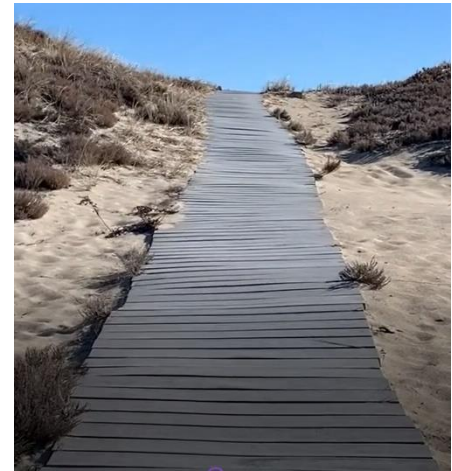
Figure 1: Apparent tilting approaching dune crest; moderate incline; footsteps observed in unvegetated areas.

- The initial portion of the walkway is flat and stable.
- There are two benches on the north side of the walkway positioned at an approximate 45 and 90-degree angle.
- The walkway becomes noticeably steep as it approaches the crest of the dune with several bowed and tilting planks (Figure 1).
- Unvegetated areas on landward side of dune crest (*Hudsonia maritime* shrubland) with footsteps in sand suggests this sensitive area is used by people (Figure 2).
- Unvegetated areas present adjacent to the walkway.
- Walking paths to homes have contributed to large unvegetated areas.
- Earthstar mushrooms found at this site (likely *Astraeus hygrometricus*) (figure 4).
- Nonnative and/or invasive species are present on site, including nonnative pine trees.

- Install non-slip surfacing on the steeper portion of the walkway to improve traction.
- Evaluate the potential for installing handrails on the steeper portions of the walkway to improve accessibility.
- Inspect and secure any loose or warped planks to restore an even walking surface.
- Install a Mobi Mat or similar ADA-compliant beach access mat at the end of the walkway to improve accessibility.
- Delineate walking paths from homes, consider routing the paths perpendicular to the walk along the edge of the dune close to the houses to limit dune impacts. Limit walking through dunes to designated walkways.
- Revegetate areas of bare sand and sparse vegetation with native species.
- Remove invasive species and revegetate with native species.

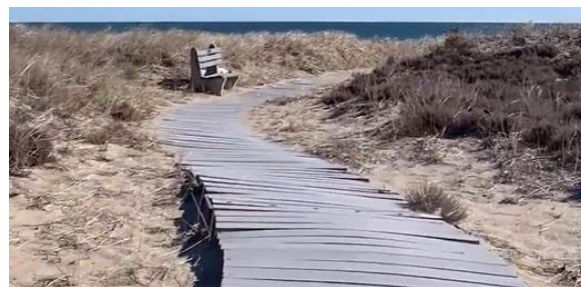
Figure 3: Observed tilting and bowing of some planks; apparent pedestrian use adjacent to the boardwalk.

- The walkway at the dune crest appears to be shifting and tilting, with multiple planks showing signs of bowing (Figure 3).
- There is one bench on the north side of walkway positioned parallel to it.
