Seabrook Dune Walkway Evaluation Final Report

Photo Credit: Tom Morgan

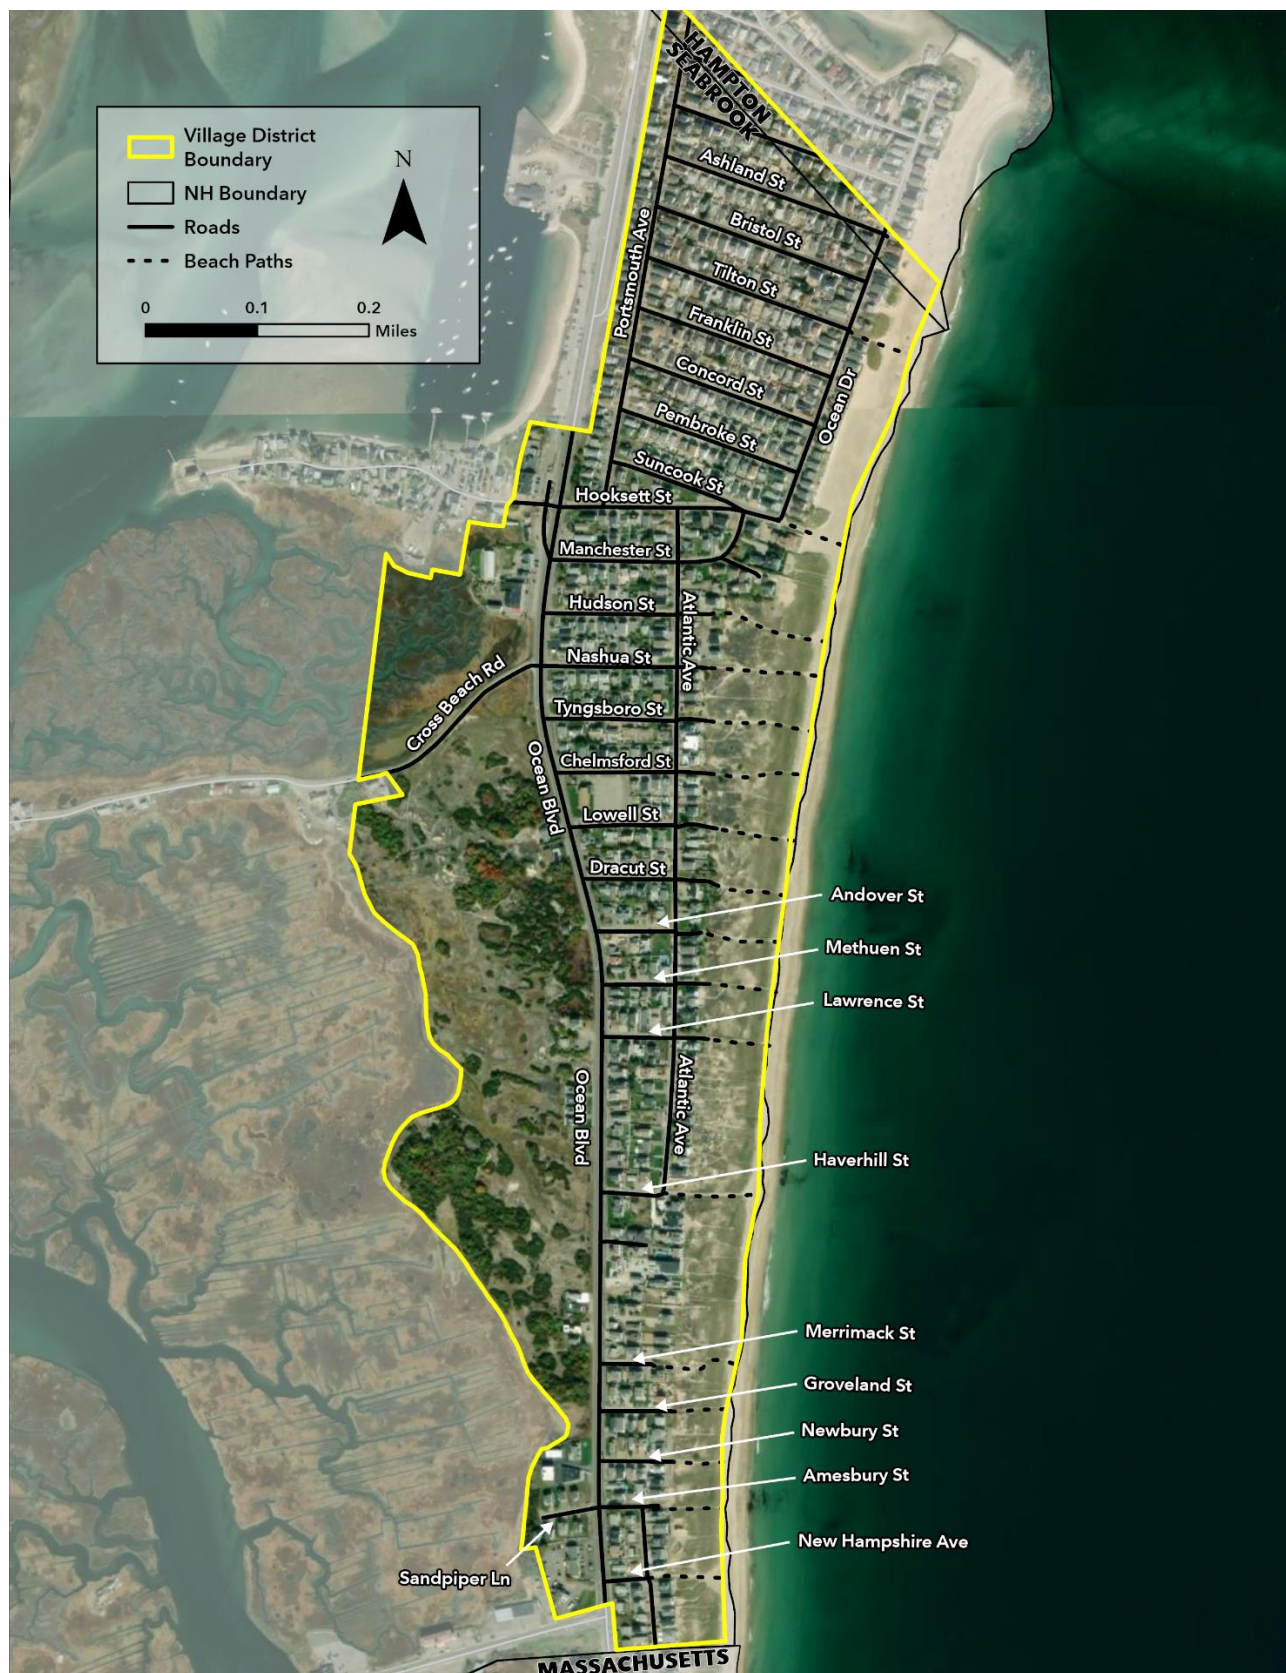
Ownership and Management

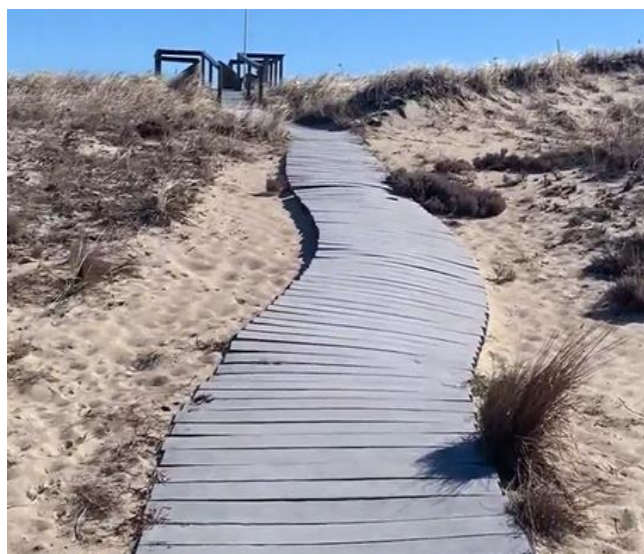
Figure 3: Shifting boardwalk foundation; bare areas of sand and footprints observed alongside the walkway; Chelmsford Street

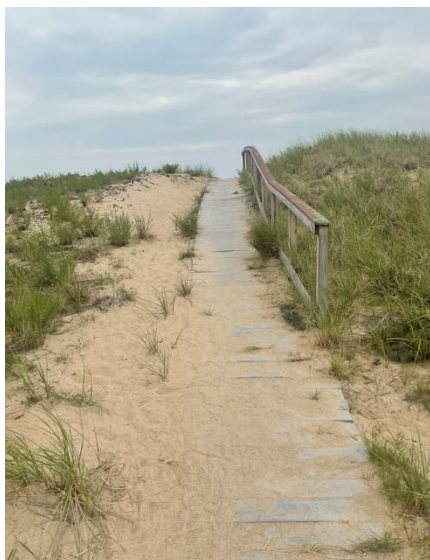
Figure 4: Sand accumulation on boardwalk, bare areas of sand and footprints observed alongside the walkway; Andover Street

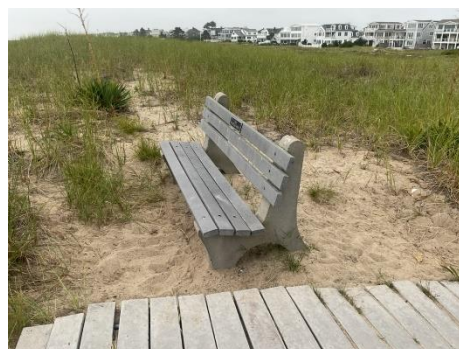
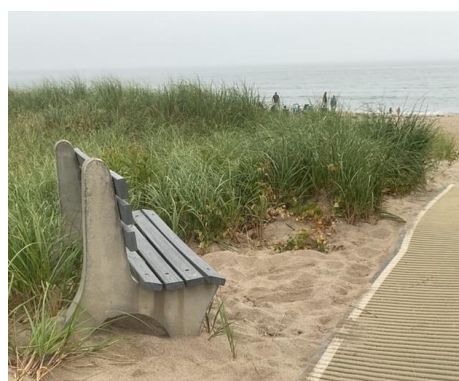
Figure 5: Observed difference in pedestrian impact with bench orientation.

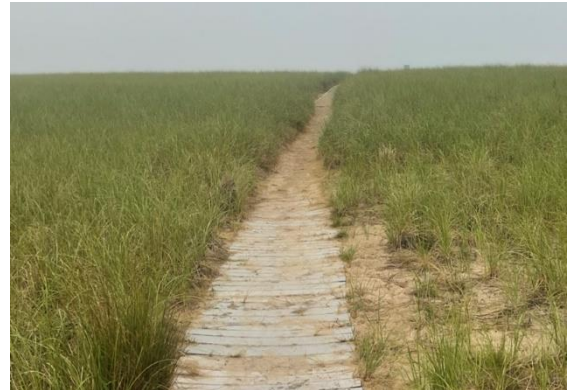
Figure 8: Beachgrass grassland

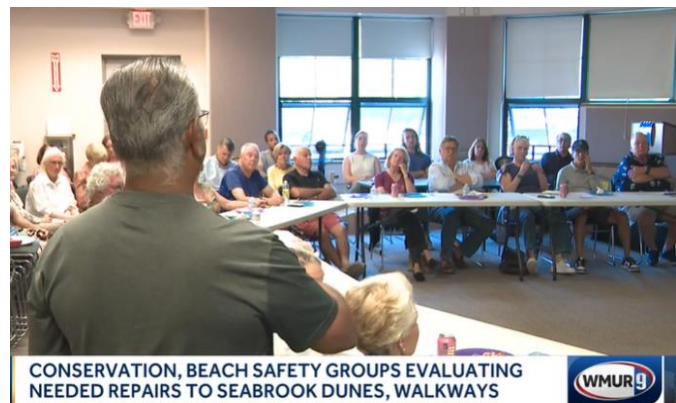
Figure 9: Select Board Member Ravi Ravikumar addresses residents at Public Workshop May 28, 2024, retrieved from WMUR

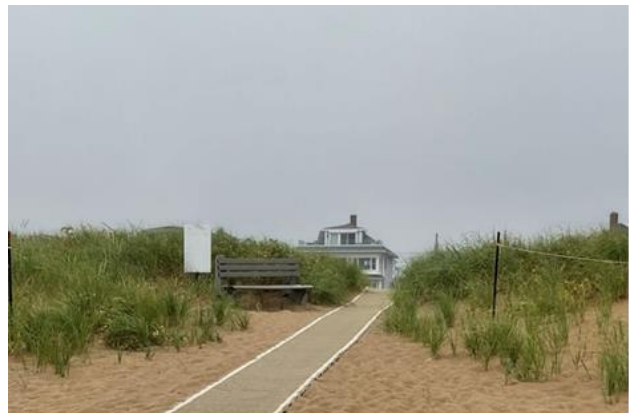
Figure 10: Mobi Mat at Groveland Street, Seabrook

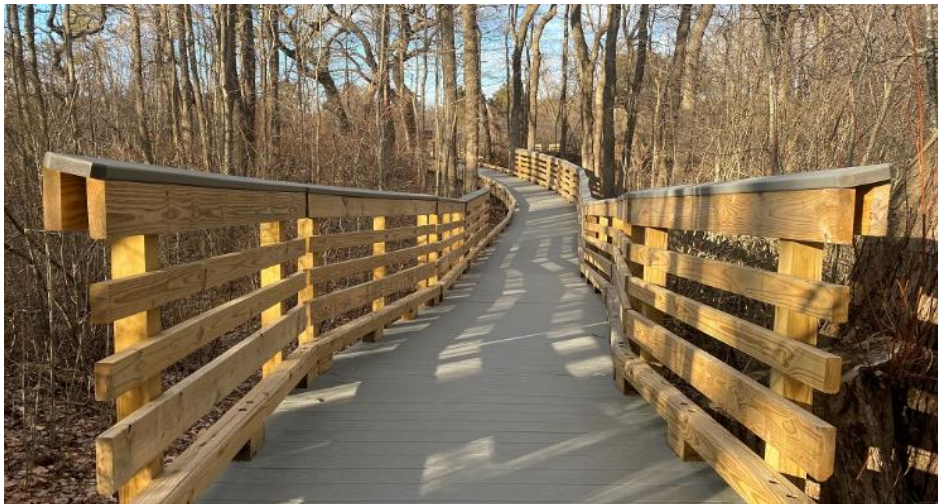
The Hellcat Interpretive Trail in the Parker River National Wildlife Refuge on Plum Island is a 1.4-mile boardwalk system that traverses both dune and marsh habitats and was designed with public access and environmental education in mind. Divided into two segments, the boardwalk includes interpretive signage, wildlife observation areas, and a fully accessible surface suitable for wheelchairs and strollers.

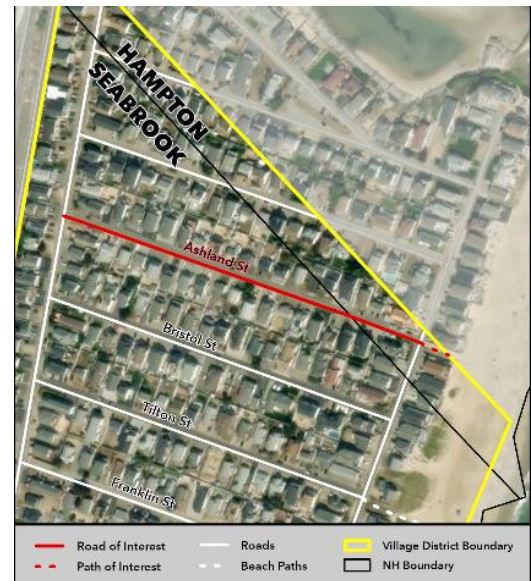
Ecological Conditions and Observations			
Community Types Present	Rare Species	Other Native Species of interest	Species of Concern
Not applicable	None observed on assessment dates	<ul style="list-style-type: none"> Beachgrass (<i>Ammophila breviligulata</i>) Beach pea (<i>Lathyrus japonicus</i>) Common Milkweed (<i>Asclepias syriaca</i>) Sea rocket (<i>Cakile edentula</i>) 	<ul style="list-style-type: none"> Beach rose (<i>Rosa rugosa</i>)^w
W = NH invasive watch list

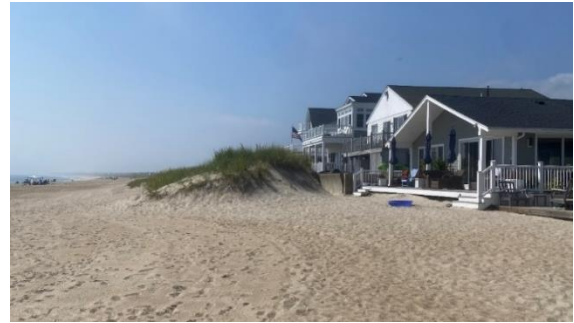
Figure 1: Small dune system in front of homes to the south.

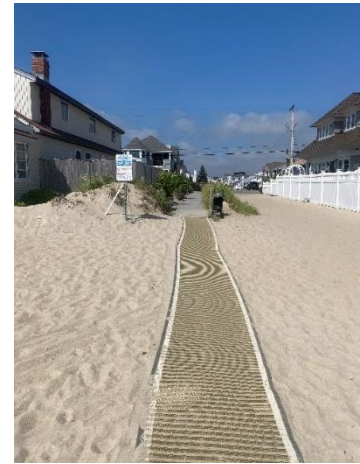
Figure 2: Mobi mat observed in August

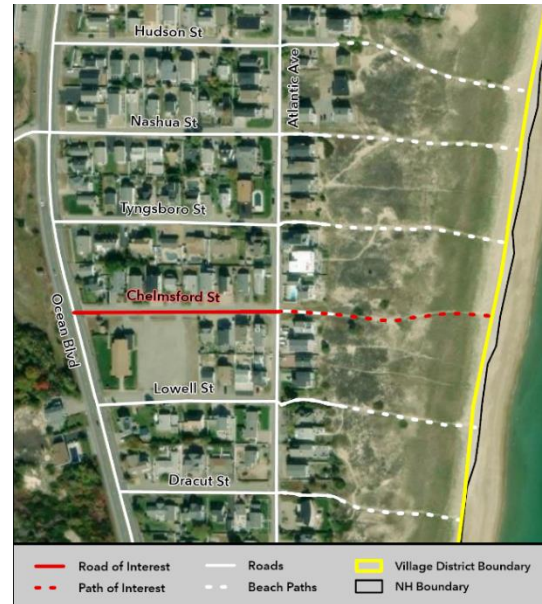
Ecological Conditions and Observations			
Community Types Present	Rare Species	Other Native Species of interest	Species of Concern
<ul style="list-style-type: none"> Beachgrass grassland Hudsonia maritime shrubland 	<ul style="list-style-type: none"> Wooly beach heather (<i>Hudsonia tomentosa</i>)^{S2} Tall wormwood (<i>Artemisia campestris</i>)^{S1} 	<ul style="list-style-type: none"> Beachgrass (<i>Ammophila breviligulata</i>) Seaside goldenrod (<i>Solidago sempervirens</i>) Northern Bayberry (<i>Myrica pennsylvanica</i>) Beach plum (<i>Prunus maritima</i>) 	<ul style="list-style-type: none"> Asiatic bittersweet (<i>Celastrus orbiculatus</i>)^P Shrub honeysuckle (<i>Lonicera species</i>)^P Beach rose (<i>Rosa rugosa</i>)^W

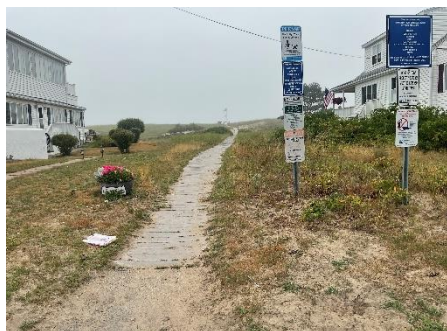
S1 = endangered in NH, S2 = threatened in NH, P = prohibited species in NH, W = NH invasive watch list

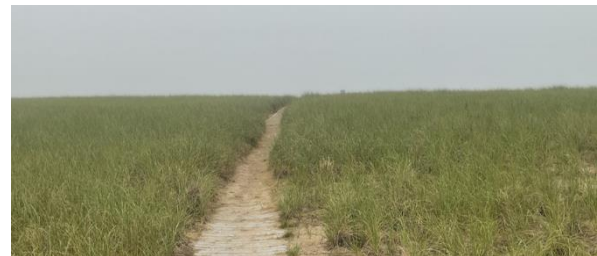
Figure 3: Well vegetated seaward side of dune

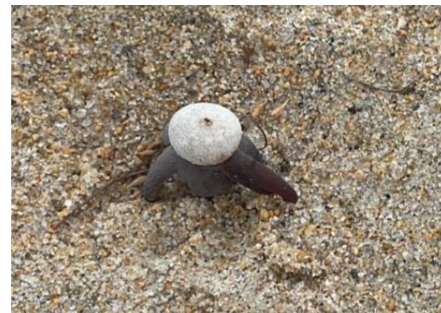
Figure 4: Earthstar mushrooms found at this site

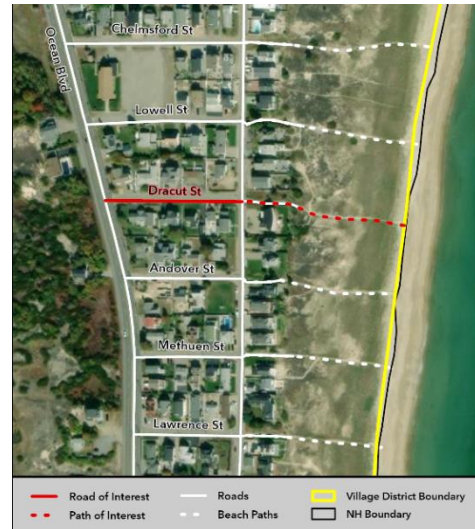
Ecological Conditions and Observations

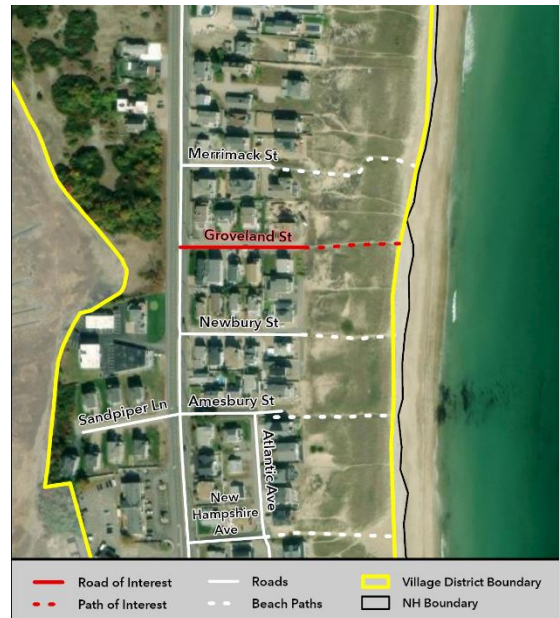
Ecological Conditions and Observations			
Community Types Present	Rare Species	Other Native Species of interest	Species of Concern
<ul style="list-style-type: none"> Beachgrass grassland Hudsonia maritime shrubland 	<ul style="list-style-type: none"> Woolly beach heather (<i>Hudsonia tomentosa</i>)^{S2} Tall wormwood (<i>Artemisia campestris</i>)^{S1} 	<ul style="list-style-type: none"> Beachgrass (<i>Ammophila breviligulata</i>) Seaside goldenrod (<i>Solidago sempervirens</i>) Beach pea (<i>Lathyrus japonicus</i>) Seabeach pinweed (<i>Lechea maritima</i>) Poison ivy (<i>Toxicodendron radicans</i>) 	<ul style="list-style-type: none"> Asiatic bittersweet (<i>Celastrus orbiculatus</i>)^P Beach rose (<i>Rosa rugosa</i>)^W
S1 = endangered in NH, S2 = threatened in NH, P = prohibited species in NH, W = NH invasive watch list

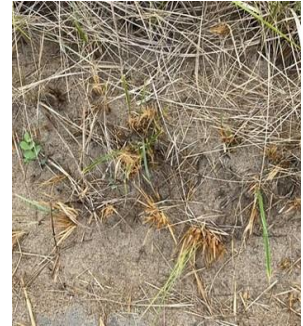
Figure 1. Cut vegetation along walkway edge

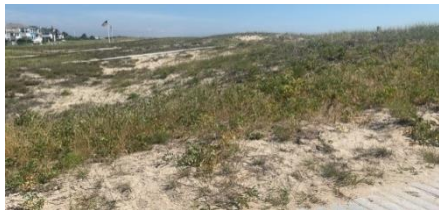
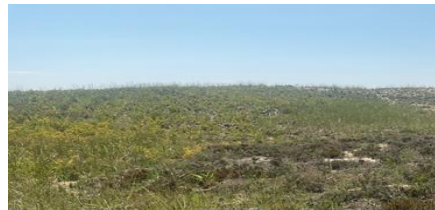
Figure 3. Vegetation to north of the walkway (right) is more sparse than south (left)

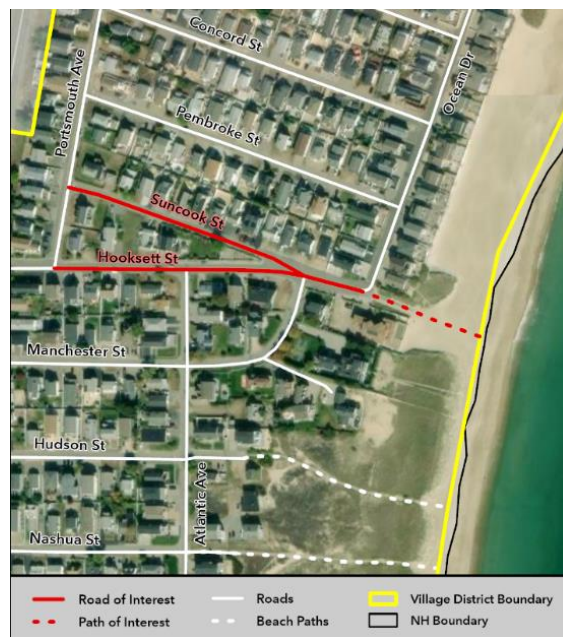
Ecological Conditions and Observations			
Community Types Present	Rare Species	Other Native Species of Interest	Species of Concern
NA	None observed on assessment dates	<ul style="list-style-type: none"> Beachgrass (<i>Ammophila breviligulata</i>) Seaside goldenrod (<i>Solidago sempervirens</i>) Beach pea (<i>Lathyrus japonicus</i>) Northern Bayberry (<i>Myrica pennsylvanica</i>) 	None observed on assessment dates

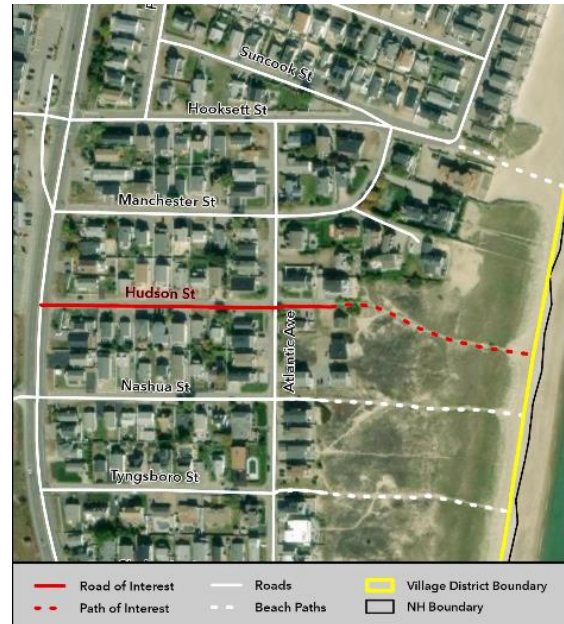
Ecological Conditions and Observations			
Community Types Present	Rare Species	Other Native Species of Interest	Species of Concern*
<ul style="list-style-type: none"> • Beachgrass grassland • Hudsonia maritime shrubland 	<ul style="list-style-type: none"> • Woolly beach heather (<i>Hudsonia tomentosa</i>)^{S2} 	<ul style="list-style-type: none"> • Beachgrass (<i>Ammophila breviligulata</i>) • Seaside goldenrod (<i>Solidago sempervirens</i>) • Beach pea (<i>Lathyrus japonicus</i>) • Northern Bayberry (<i>Myrica pennsylvanica</i>) • Common milkweed (<i>Asclepias syriaca</i>) 	<ul style="list-style-type: none"> • Asiatic bittersweet^P (<i>Celastrus orbiculatus</i>) • Beach rose^W (<i>Rosa rugosa</i>) • Yucca species (likely <i>Yucca filamentosa</i>) • Shrub honeysuckle^P (<i>Lonicera species</i>)
S2 = threatened in NH, P = prohibited species in NH, W = NH invasive watch list

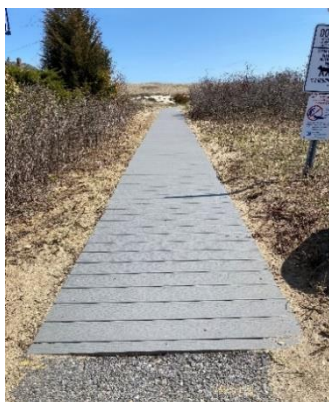
Walkway entrance (2025)

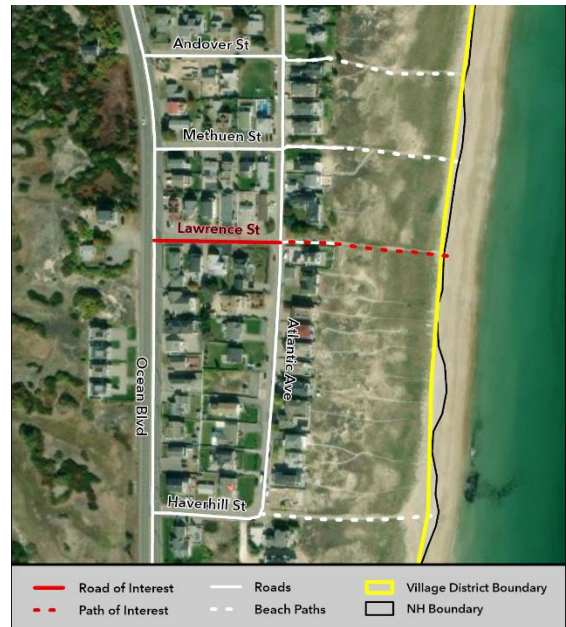
Structure Conditions and Observations	
Road to Beach	504 ft
Boardwalk Length	415 ft
End of boardwalk to beach	89 ft
Walkway Width	4.0 ft
Boardwalk Material	<ul style="list-style-type: none"> Asphalt apron Pressure treated wood connected by galvanized cable
Attached pathways	2
Benches	2
Additional Features	<ul style="list-style-type: none"> Wooden viewing platform with benches at dune crest Seasonal Mobi Mat installed to extend wooden walkway over sand to beach
*Human-made pathways connected to the municipal walkway

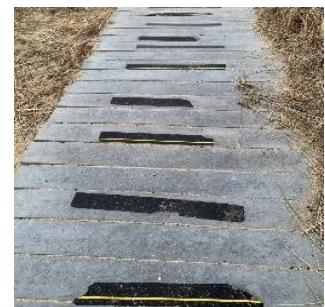
Figure 3. Previously installed slip resistant tape

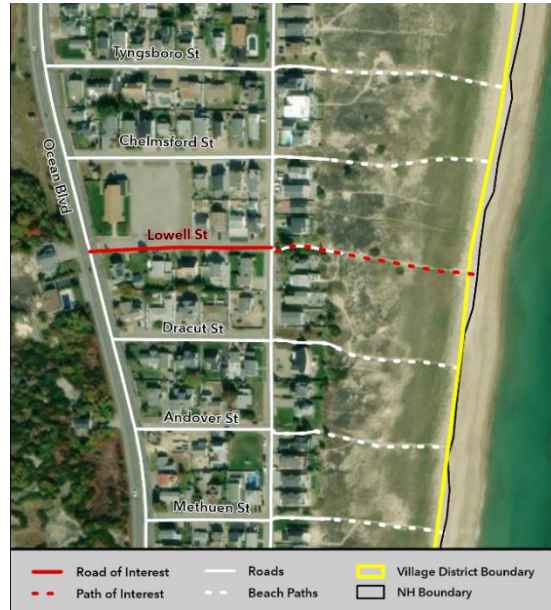
Structure Conditions and Observations:	
Road to Beach	500 ft
Boardwalk Length	430 ft
End of boardwalk to the beach	70 ft
Walkway Width	4.0 ft
Walkway Material	<ul style="list-style-type: none"> Asphalt apron Pressure treated wood connected by cable
Connected pathways**	2
Benches	3
Additional Features	viewing platform at crest of dune with benches
*Human-made pathways connected to the municipal walkway

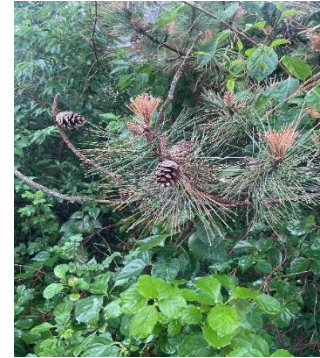
Figure 1: Nonnative pine species observed at the entrance to the walkway

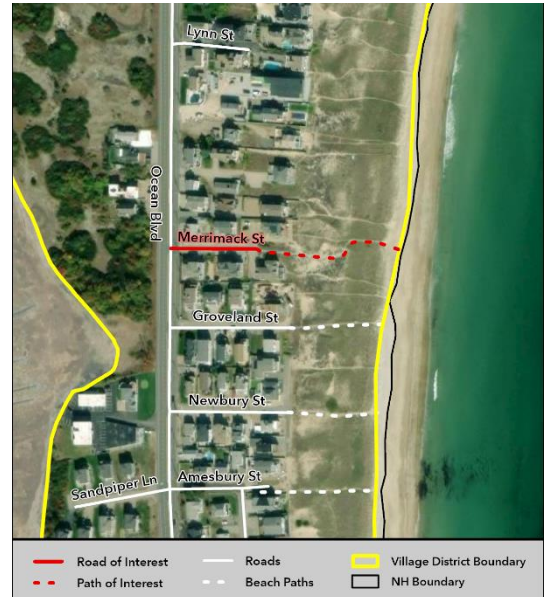
Structure Conditions and Observations	
Road to Beach	474 ft
Boardwalk Length	380 ft
End of boardwalk to beach	94 ft
Walkway Width	4.0 ft
Boardwalk Material	<ul style="list-style-type: none"> Asphalt apron Pressure treated wood connected by galvanized cable
Attached pathways	3 with others seen adjacent
Benches	1
Additional Features	<ul style="list-style-type: none"> Fire hydrant at entrance Seasonal Mobi Mat installed to extend wooden walkway over sand to beach
*Human-made pathways connected to the municipal walkway

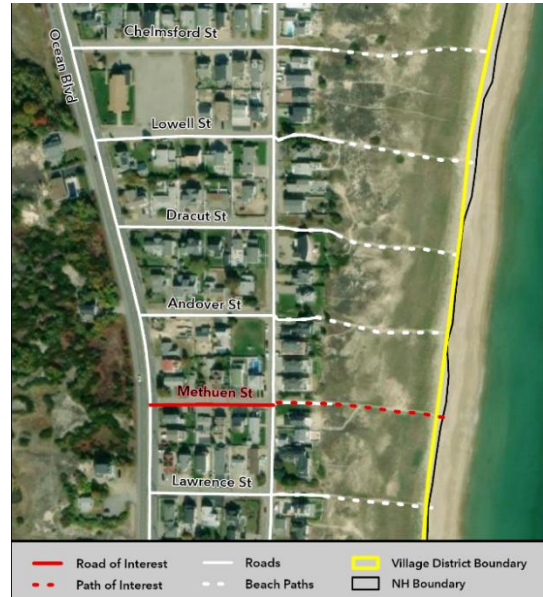
Ecological Conditions and Observations			
Community Types Present	Rare Species	Other Native Species of interest	Species of Concern
<ul style="list-style-type: none"> Beachgrass grassland Hudsonia maritime shrubland 	<ul style="list-style-type: none"> Woolly beach heather (<i>Hudsonia tomentosa</i>)^{S2} Gray's sedge (<i>Cyperus grayi</i>)^{S1} Tall wormwood (<i>Artemisia campestris</i>)^{S1} 	<ul style="list-style-type: none"> Beachgrass (<i>Ammophila breviligulata</i>) Seaside goldenrod (<i>Solidago sempervirens</i>) Beach pea (<i>Lathyrus japonicus</i>) Beach plum (<i>Prunus maritima</i>) Seabeach pinweed (<i>Lechea maritima</i>) Bayberry (<i>Myrica pennsylvanica</i>) 	<ul style="list-style-type: none"> Asiatic bittersweet (<i>Celastrus orbiculatus</i>)^P
S1 = endangered in NH, S2 = threatened in NH, P = prohibited species in NH, W = NH invasive watch list

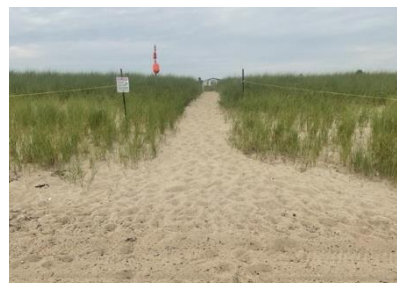
Figure 5. Seaward end of walkway

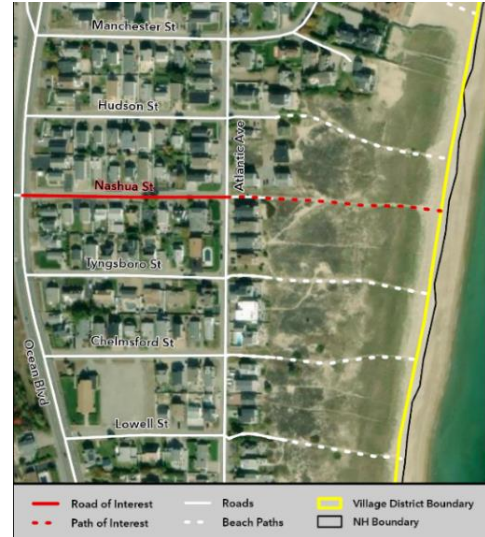
Ecological Conditions and Observations			
Community Types Present	Rare Species	Other Native Species of interest	Species of Concern
<ul style="list-style-type: none"> Beachgrass grassland Hudsonia maritime shrubland 	<ul style="list-style-type: none"> Wooly beach heather (<i>Hudsonia tomentosa</i>)^{S2} 	<ul style="list-style-type: none"> Beachgrass (<i>Ammophila breviligulata</i>) Seaside goldenrod (<i>Solidago sempervirens</i>) Northern Bayberry (<i>Myrica pennsylvanica</i>) 	<ul style="list-style-type: none"> Autumn olive (<i>Elaeagnus umbellata</i>)^P Climbing nightshade (<i>Solanum dulcamara</i>)^W Beach rose (<i>Rosa rugosa</i>)^W
S2 = threatened in NH, P = prohibited species in NH, W = NH invasive watch list

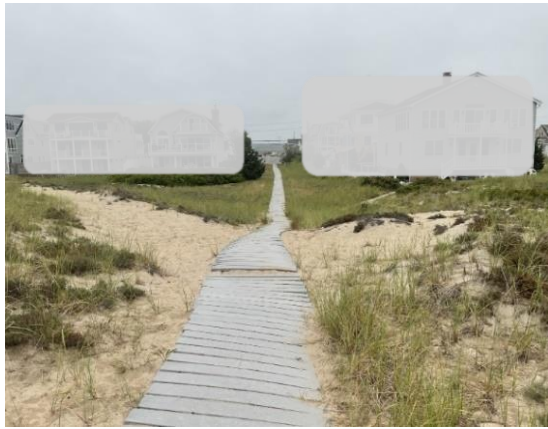
Figure 3: Large unvegetated areas adjacent to walkway

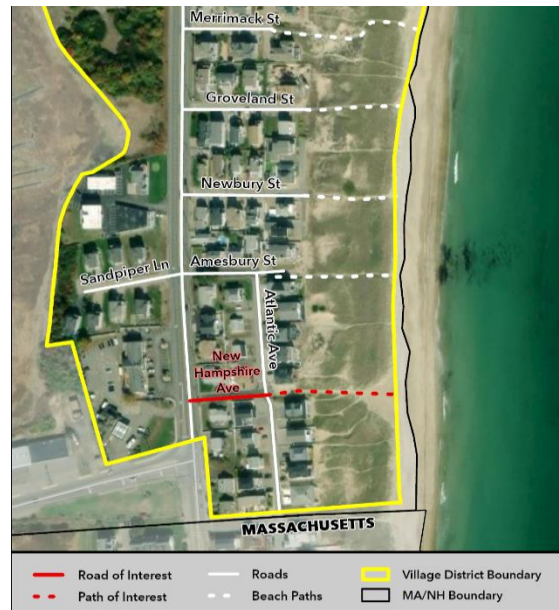
Ecological Conditions and Observations			
Community Types Present	Rare Species	Other Native Species of interest	Species of Concern
<ul style="list-style-type: none"> • Beachgrass grassland 	None observed on assessment dates	<ul style="list-style-type: none"> • Beachgrass (<i>Ammophila breviligulata</i>) • Seaside goldenrod (<i>Solidago sempervirens</i>) • Beach pea (<i>Lathyrus japonicus</i>) 	<ul style="list-style-type: none"> • Asiatic bittersweet (<i>Celastrus orbiculatus</i>)^P • Beach Rose (<i>Rosa rugosa</i>)^W • Shrub honeysuckle (<i>Lonicera species</i>)^P
P = prohibited species in NH; W = NH invasive watch list

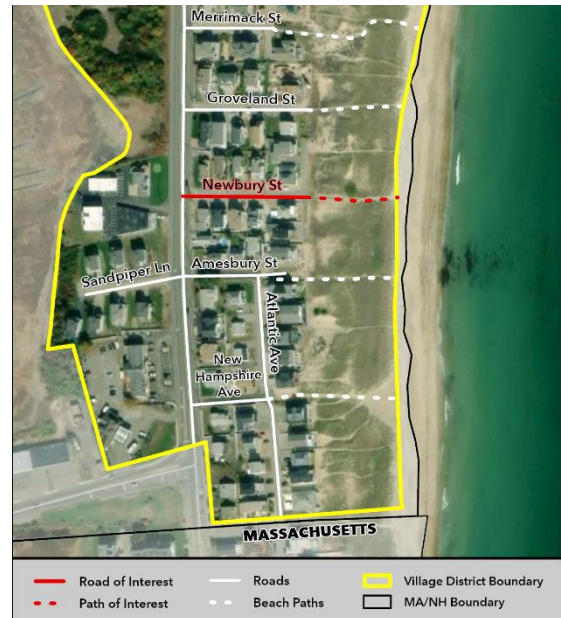
Ecological Conditions and Observations			
Community Types Present	Rare Species	Other Native Species of interest	Species of Concern
<ul style="list-style-type: none"> Beachgrass grassland 	<ul style="list-style-type: none"> Tall wormwood (<i>Artemisia campestris</i>)^{S1} 	<ul style="list-style-type: none"> Beachgrass (<i>Ammophila breviligulata</i>) Seaside goldenrod (<i>Solidago sempervirens</i>) Beach pea (<i>Lathyrus japonicus</i>) Seabeach pinweed (<i>Lechea maritima</i>) 	<ul style="list-style-type: none"> Asiatic bittersweet (<i>Celastrus orbiculatus</i>)^P Beach Rose (<i>Rosa rugosa</i>)^W
S1 = endangered in NH, P = prohibited species in NH, W = NH invasive watch list

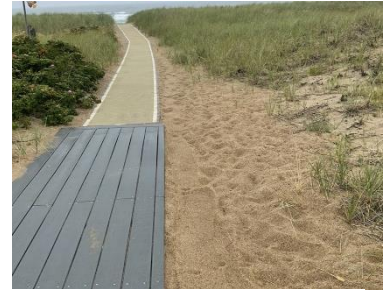
Figure 1. Foot traffic along walkway edges impacting vegetation

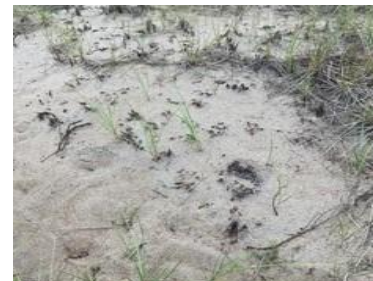
Figure 3. Unvegetated areas suggesting dune die-off

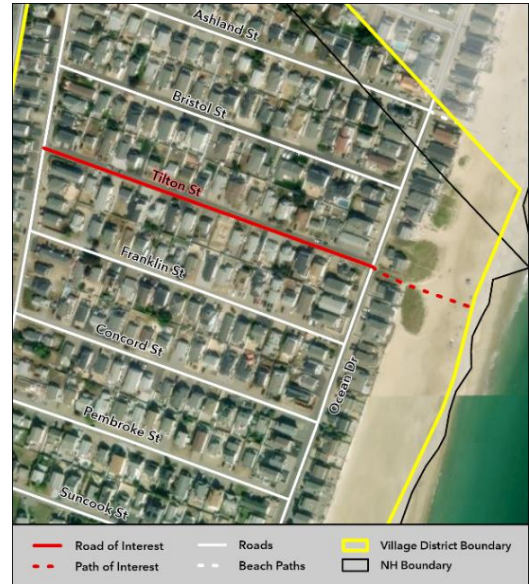
Ecological Conditions and Observations			
Community Types Present	Rare Species	Other Native Species of interest	Species of Concern
Not applicable	None observed on assessment dates	<ul style="list-style-type: none"> Beachgrass (<i>Ammophila breviligulata</i>) Seaside goldenrod (<i>Solidago sempervirens</i>) Beach pea (<i>Lathyrus japonicus</i>) Common Milkweed (<i>Asclepias syriaca</i>) 	None observed on assessment dates.

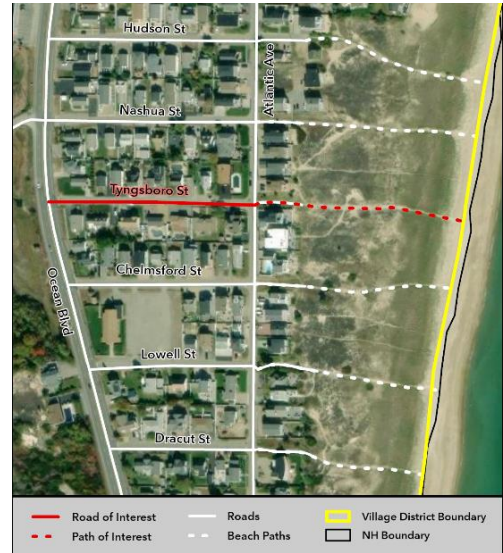
Ecological Conditions and Observations			
Community Types Present	Rare Species	Other Native Species of interest	Species of Concern
<ul style="list-style-type: none"> Beachgrass grassland Hudsonia maritime shrubland 	<ul style="list-style-type: none"> Wooly beach heather (<i>Hudsonia tomentosa</i>)^{S2} 	<ul style="list-style-type: none"> Beachgrass (<i>Ammophila breviligulata</i>) Common Milkweed (<i>Asclepias syriaca</i>) 	<ul style="list-style-type: none"> Asiatic bittersweet (<i>Celastrus orbiculatus</i>)^P
S2 = threatened in NH, P = prohibited species in NH

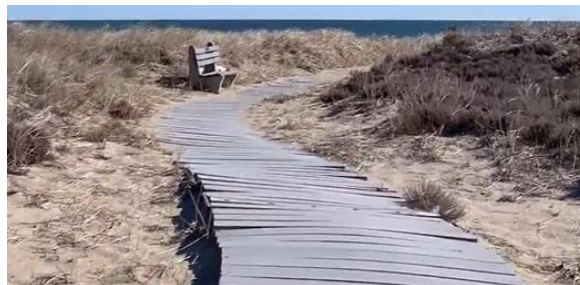
Figure 3: Observed tilting and bowing of some planks; apparent pedestrian use adjacent to the boardwalk.

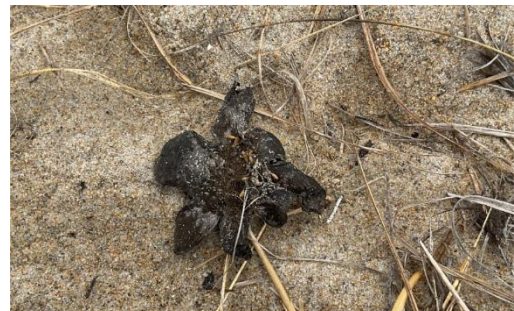
Figure 4: Earthstar Mushroom

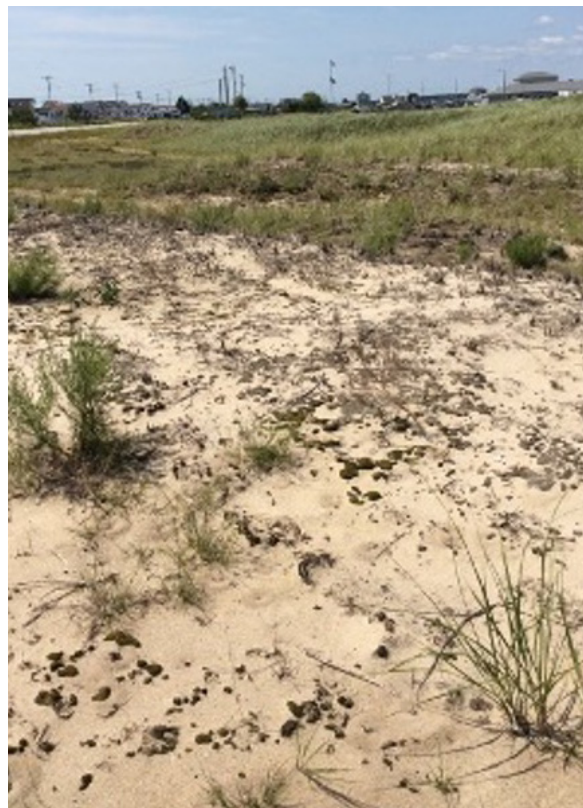
For questions about dune die-off, contact:

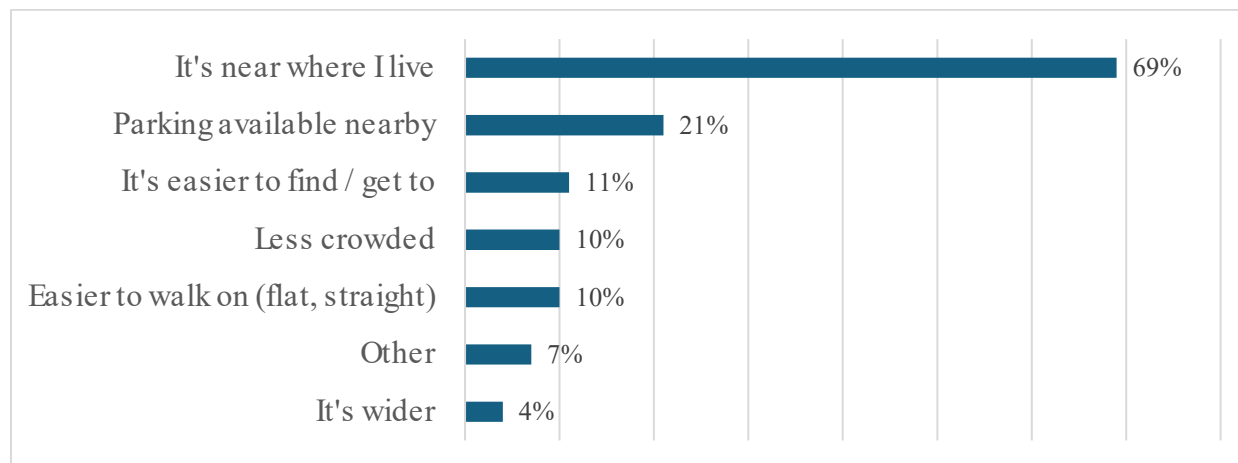
Question 11: Which of the following features do you like most about the municipal walkways? Select all that apply. (Not all the walkways have these features.) (Total Responses: 244)
