Chelmsford Street: Dune Walkway Profile

Site Assessments: February 21, 2024, July 25, 2024, and May 23, 2025

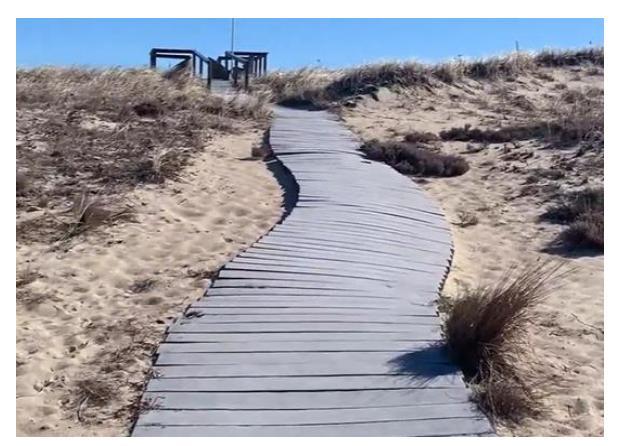
Figure 1: Boardwalk shifting near dune crest

- The initial portion of the walkway is flat and stable.
- A small section of the boardwalk near the dune crest appears to be shifting slightly to the right (Figure 1), resulting in an uneven and tilted walking surface.
- Dense vegetation is present at the walkway entrance, consisting primarily of crabgrass (*Digitaria* species) and other non-dune species, including invasive species (Figure 2).
- Some sparsely vegetated areas on the landward side of the dune.
- Nonnative pine trees are present on the site.

- Reinforce or realign the boardwalk and stabilize to prevent further shifting.
- Install a Mobi Mat or similar ADA-compliant beach access mat at the end of the walkway to improve accessibility.

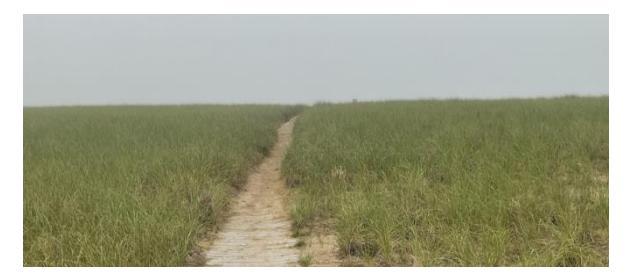
Figure 3: Well vegetated seaward side of dune

- There are a few sections that have bowed or loose planks, which may pose a tripping hazard.
- Walkway buried by sand at the bottom toward the beach.
- There is one bench along the north side of the walkway, positioned parallel to it.
- The seaward side of the dune is wellvegetated (Figure 3).

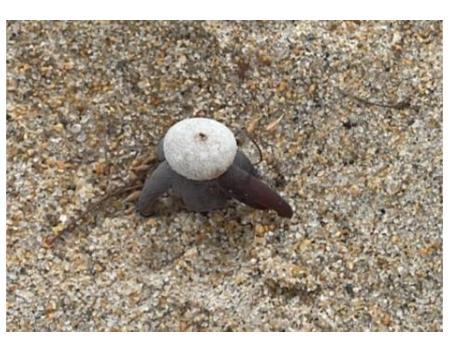
Figure 4: Earthstar mushrooms found at this site

• Earthstar mushrooms found at this site (likely Astraeus hygrometricus).

The mushroom observed at this site is likely in the genus Astraeus – the false earthstars. They are often called the "Barometer Earthster" as the rays of the star open and close based on the humidity.
