Haverhill Street: Dune Walkway Profile

Site Assessments: March 5, 2024, July 8, 2024, and May 23, 2005

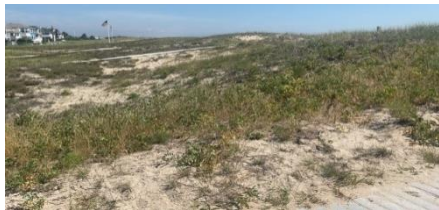
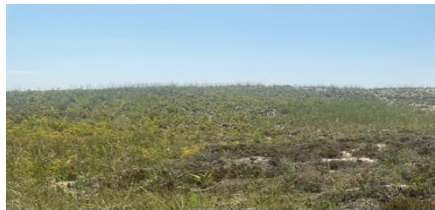
- The landward area to the south of the walkway is unvegetated (Figure 1). The area to the north of the walkway has recently planted beachgrass (as of May 2025)
- A walking path to homes connects to the municipal path perpendicularly and along the back side of the dune.
- An unvegetated area was observed to the north of the walkway (Figure 2).
- The vegetation to the north of the walkway is more sparse than to the south (Figure 3).

Figure 3. Vegetation to north of the walkway (right) is more sparse than south (left)

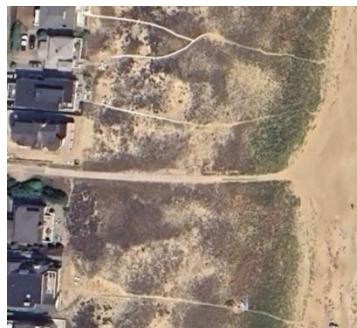
- There are two benches located near the beach entrance on the north and south sides and each bench is oriented parallel to path.
- The seaward end of the walkway is less vegetated and widens, creating a weak point for flooding during storms (Figure 5).

Figure 5. Wider less vegetated seaward end of walkway

- Restore sand dune vegetation to create a narrower path on the seaward end of the walkway. Consider orienting the seaward end of the walkway away from the dominant wind and wave directions.

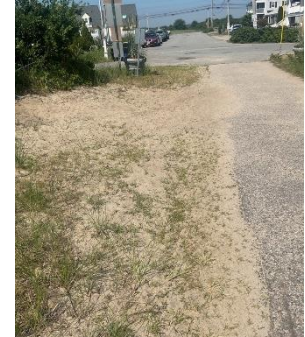
Figure 1. south side of entrance is unvegetated

- Revegetate the landward area to the south of the walkway near the road with native dune species as this area is currently vulnerable to colonization by invasive species.

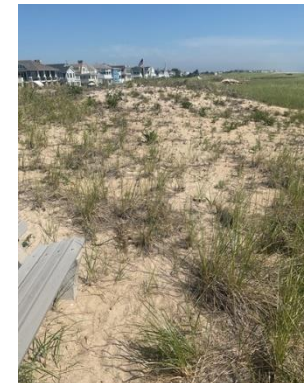
Figure 2. Unvegetated area to the north of walkway

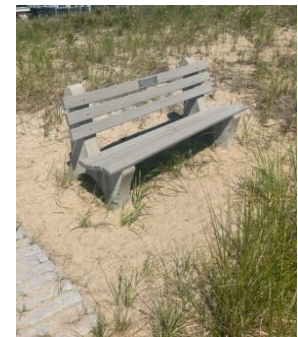
- Former dune die-off area suspected on the dune crest where beachgrass is sparse, and the primary species present are goldenrod and beach pea.
- Then a second one located close to the end of the wooden portion of the walkway on the northside and oriented perpendicular to it. The area around the bench is unvegetated. (Figure 4).

Figure 4. Unvegetated area around bench

- Benches placed at an angle (~45°) generally appear to have less impact on the surrounding dune than benches placed perpendicular to the walkway. Consider positioning benches at a 45° angle to the walkway when practicable and revegetating the areas around them, other than directly in front.
